INDOOR AIR QUALITY ASSESSMENT

**South River Elementary School
54 Hatch Street
Marshfield, Massachusetts**

Prepared by:
Massachusetts Department of Public Health
Bureau of Environmental Health
Indoor Air Quality Program
March 2008

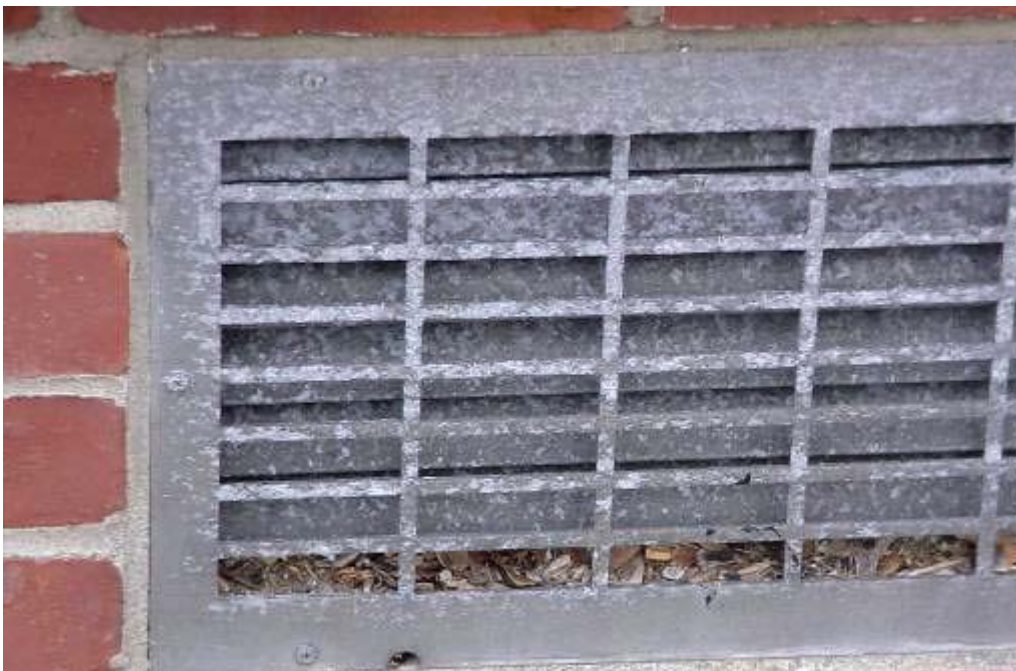
Picture 2

Univent Fresh Air Intake

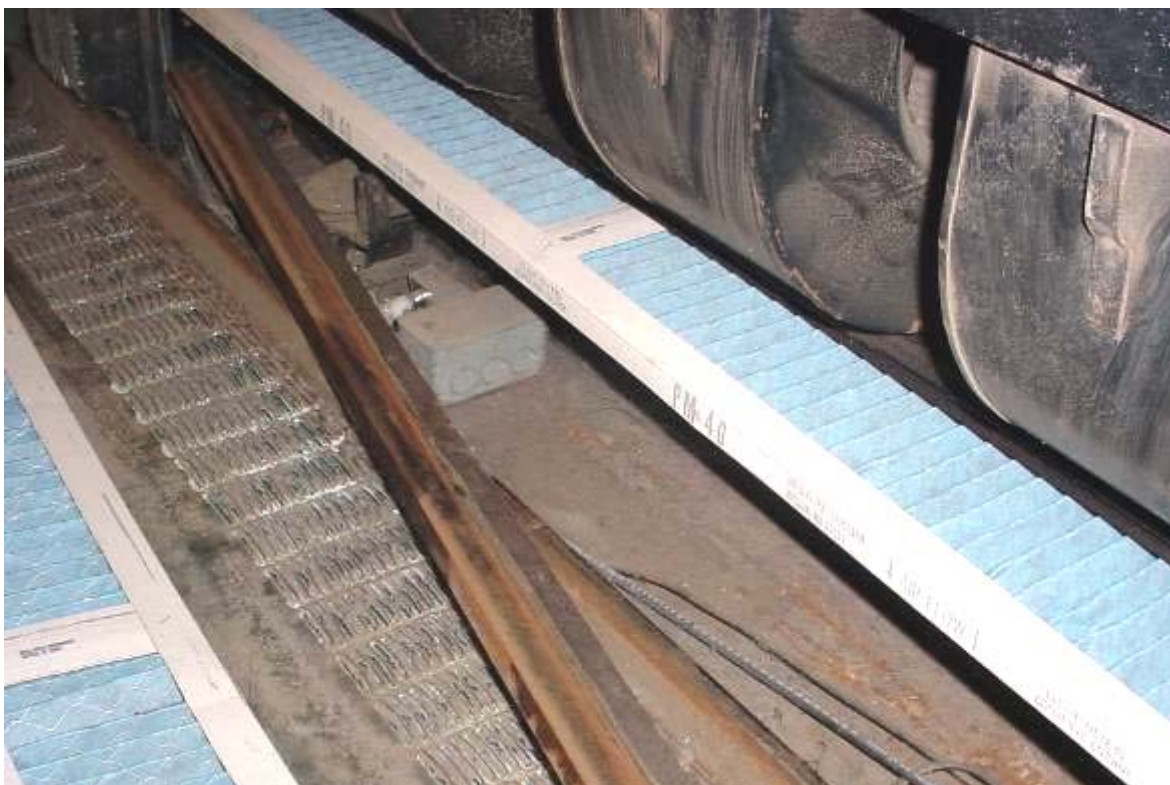
Picture 3

Set of Two Pleated Filters in Classroom Univents

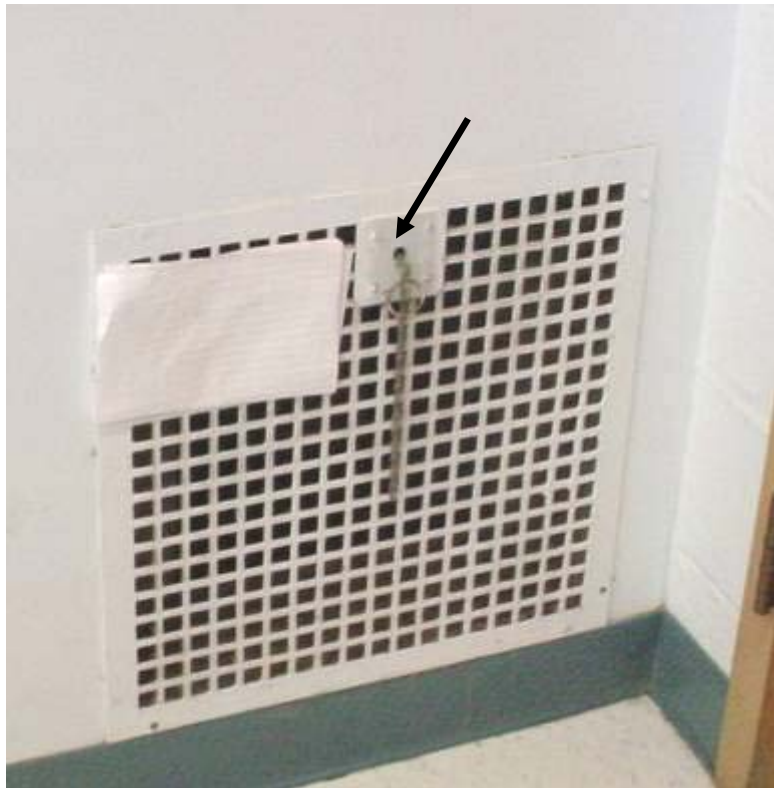
Picture 7

Exhaust vents in the 1950 portion of the building are located in floor level "cubbies" powered by a motor located in a cupola (Pictures 5 and 6). Exhaust vents for the 1952 addition are located on classroom walls (Picture 7). In both cases, the amount of airflow into the exhaust vent can be adjusted by a flue connected to a pull chain (Pictures 5 and 7). Additional exhaust vents in the 1952 classrooms are located in the ceilings of coat closets (Picture 8). Air is drawn into the coat closet from the classroom via undercut closet doors (Picture 9). Many of the exhaust vents were obstructed by various classroom items, limiting airflow (Pictures 10 and 11). In order for univents and exhaust vents to operate as designed, they must remain free of obstructions and be allowed to operate while rooms are occupied.

**Wall-Mounted Exhaust Vent with Pull Chain (Arrow) in 1952 Addition,
Suspended Paper Indicates Draw**

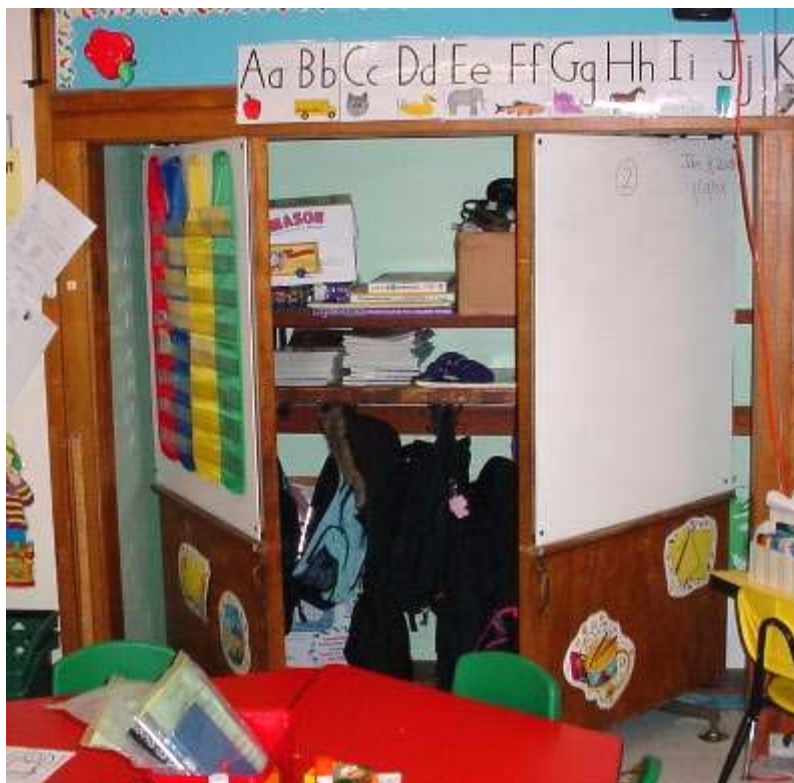
Picture 9

Swinging Doors to Coat Closet Exhaust in 1952 Portion of Building

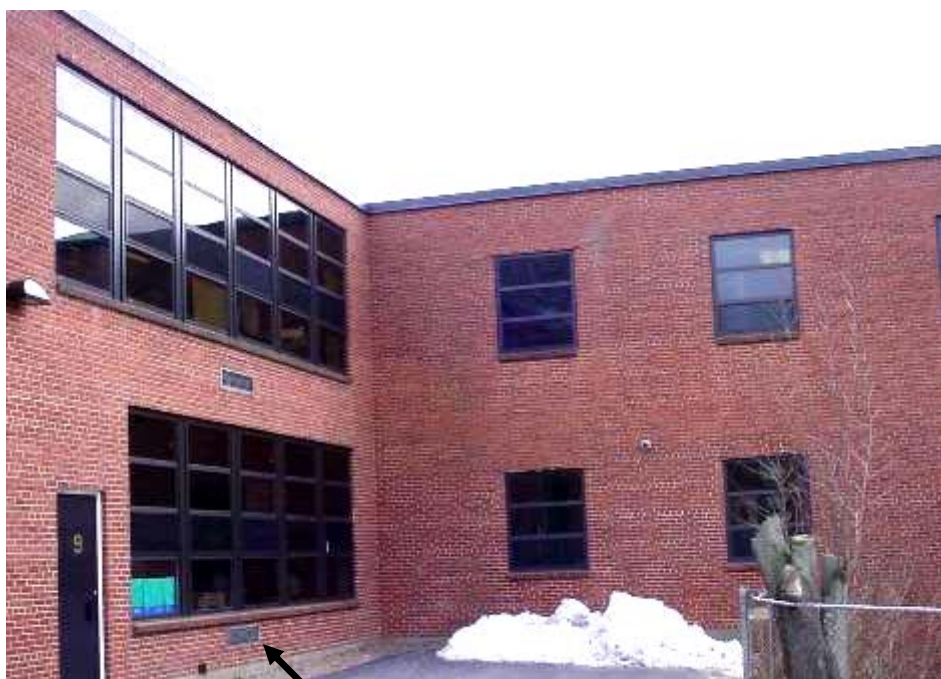
Picture 26

As reported by Principal Loiselle and Mr. Davis, black soot-like deposition was found on flat surfaces in classroom 109 in September 2006. Mr. Davis attributed the presence of the material to the start up of the boiler system; the material was cleaned and reportedly has not reoccurred. Although the start up of the boiler plant for the heating season may be the most likely source of the material, the configuration/location of the room may also contribute to accumulation of dirt, dust and debris. BEH staff examined the room and its relationship to the exterior of the building. This classroom is located at the terminus of an alcove where two wings intersect outside the building (Picture 26). Loose dirt and plant debris was observed below and had accumulated on the univent fresh air intake outside the building (Picture 27). BEH staff opened the univent cabinet to examine the interior and found similar accumulations of dirt and debris inside. It is likely that dirt dust/debris accumulates in this area due to the configuration of the outside of the building, an alcove that can trap air currents and stir up loose dirt/debris, which can then be drawn into the classroom via the univent.

Corner of Building Where Room 109 is Located, Note Location of Intake Vent

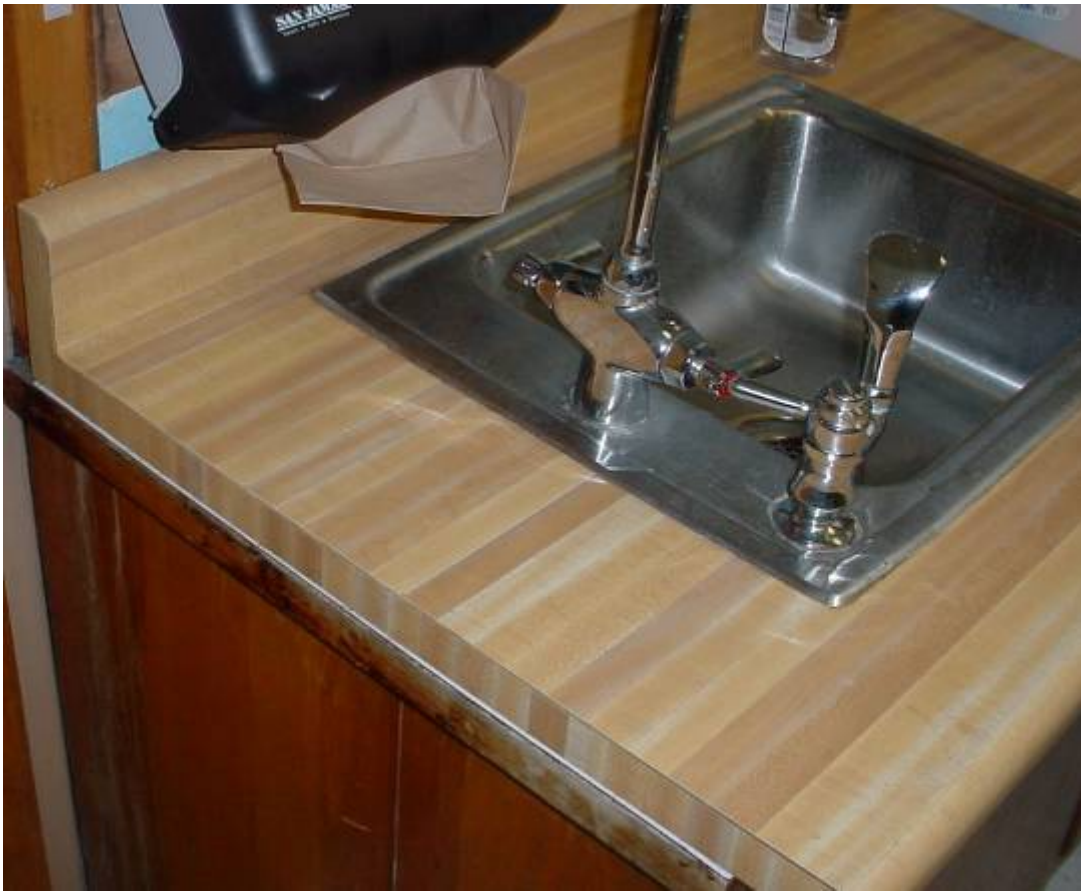
Picture 35

Molded One-Piece Sink Countertop

14. Seal areas around sinks to prevent water-damage to the interior of cabinets and adjacent wallboard. Inspect wallboard for water damage and mold growth, repair/replace as necessary. Disinfect areas with an appropriate antimicrobial, as needed. Consider replacing with single piece molded countertops as shown in Picture 35.
